Burkina Faso Flying Labs Collaborates With Namibia Flying Labs For Thermographic Inspection of a Solar Power Plant

OVERVIEW	
Flying Labs	Burkina Faso Flying Labs
Geographic area	Tenkodogo, Burkina Faso
Date range	November 2024
Sector program	DevRobotics
Main SDGs	GOAL 7: Affordable and Clean Energy GOAL 9: Industry, Innovation and Infrastructure

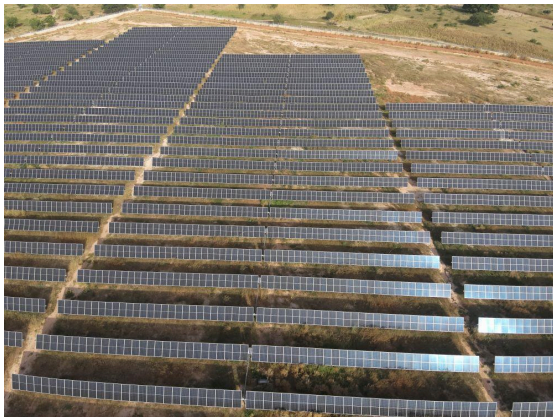
Solar power plant
