## Aerial Mapping of the 2019 Central Luzon Earthquake

### OVERVIEW

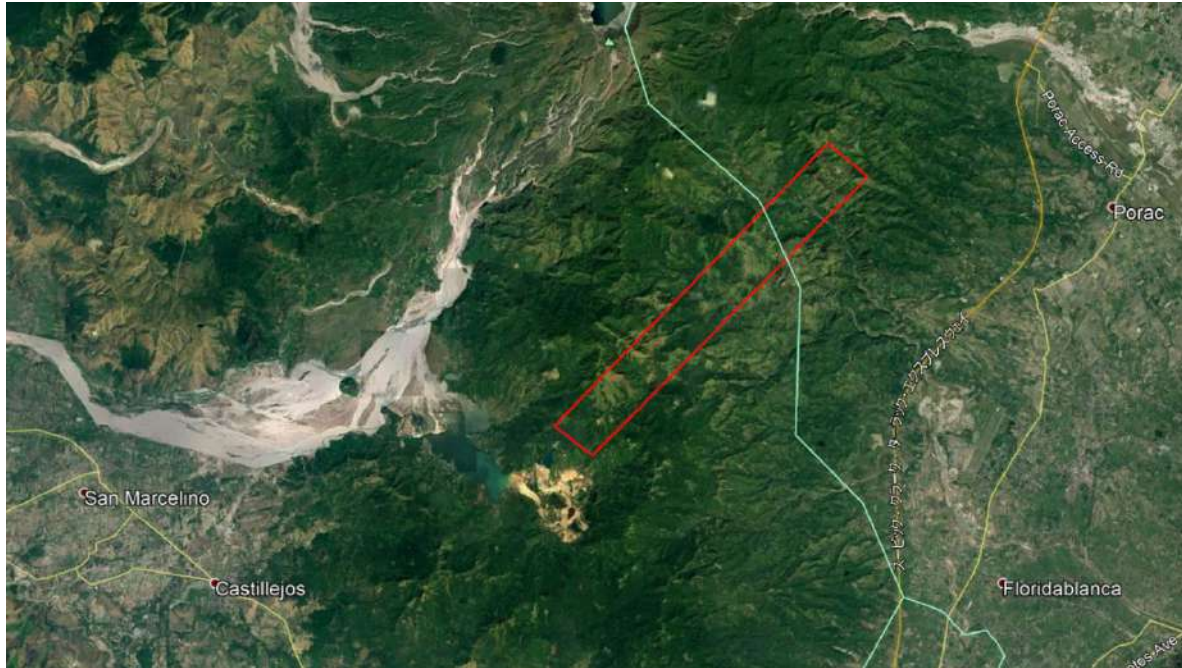
*Flight area location and suspected location of the fault line*

<b>Outcome</b>	<p>Taking into account the size of the area and the mountainous terrain, as well the rainy season during the data collection period, it was decided to use a manned aircraft based mapping system to acquire the data. The system was designed for areas of these characteristics and has been previously used in similar projects. The rainy season in this period made it difficult to find a weather window to collect aerial imagery, but the aircraft was able to cover the project area in less than half a day in a single flight in favourable weather. Collected images were processed in Pix4Dmapper the same way drone photos are processed.</p> <p>The methodology of this activity was divided into 4 parts:</p> <ol style="list-style-type: none"> <li>1. Project Planning and Preparation</li> <li>2. Data Acquisition</li> <li>3. Data Processing</li> <li>4. Data Analysis</li> </ol> <p>Project Planning and Preparation included delineation of the flight area, making arrangements with the pilot, securing necessary permits and flight planning. Based on initial studies, UPRI has located the fault line area and added sufficient buffer to produce the final mapping area.</p>

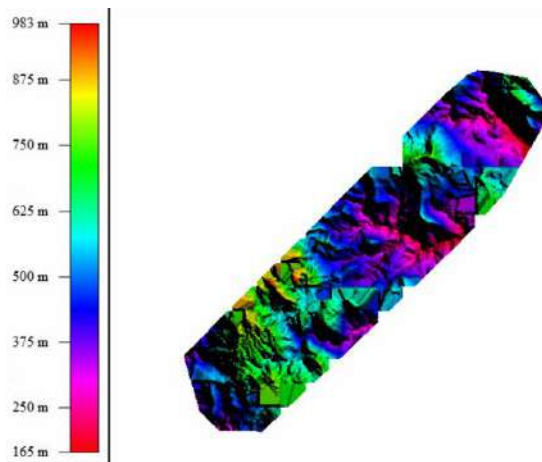
*Digital Terrain Model of the mapped area*

<b>DATA PROCESSING &amp; ANALYSIS</b>	
<b>Processing software</b>	Pix4Dmapper, Skyline Photomesh
<b>Processing time</b>	1hr for Pix4Dmapper, 2 days for Skyline Photomesh
<b>Data products</b>	Orthophoto, DSM, DTM, 3D model
<b>Analysis tools</b>	Pix4Dmapper, TerraExplorer Pro
<b>Analysis outputs</b>	3D model
<b>Final outputs shared with stakeholders</b>	Raw images, orthophoto, DSM, DTM, 3D model
<b>Data sharing</b>	Hard drive

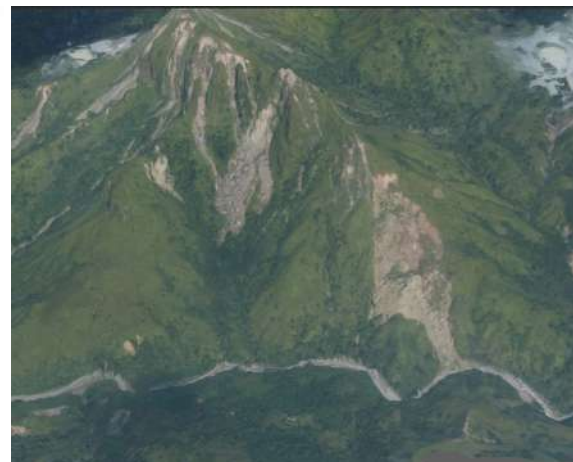
*3D model showing effects of the earthquake*

<p>In the Data Collection phase, all equipment parts of the system were properly installed and secured to the aircraft. To prepare for weather changes, flight plans with several flying heights were made for different weather conditions.</p> <p>Pix4Dmapper was used to process the images. The outputs included an orthophoto map, DSM and DTM. A 3D model of the mapping area was processed using TerraExplorer Pro. The data allowed for detailed spatial analysis of landslide trends and distribution as a result of the 2019 Central Luzon Earthquake. The outputs showed the damage to the mountains caused by the earthquake. Landslides and rockfalls were clearly visible on the orthophoto map and on the 3D map. The DTM was useful for further elevation change analysis of the damaged areas.</p>
<p><b>Next steps</b></p>	<p>With no clear source fault for the earthquake and multiple theories existing, the data can help to understand where the earthquake may have originated. The aerial data outputs and the damage that will be seen in the aerial images acquired right after the earthquake will help UPRI to ascertain the geologic effects and mechanisms related to the earthquake. The data can also be used to produce updated hazard maps which will help determine the vulnerability of the people living nearby, as well as the neighbouring towns and cities.</p>
